# **OPERATING EXPERIENCE WEEKLY SUMMARY**

**Office of Nuclear and Facility Safety**

**November 27 - December 3, 1998**

**Summary 98-48**

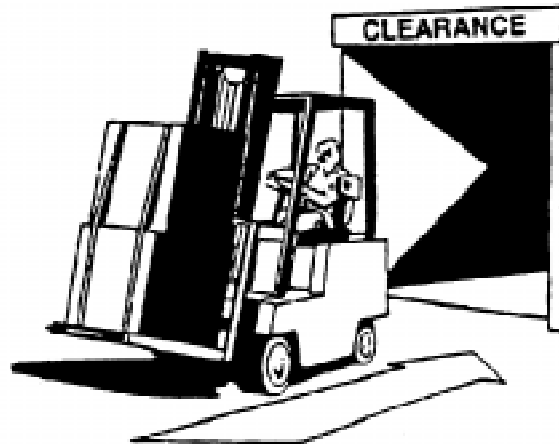
**Figure 4-1. Check the Clearances**

On November 23, 1998, at the Rocky Flats Environmental Technology Site, the mast of a fork truck came in contact with an overhead 480-V bus duct. The fork truck driver was moving supplies with the mast extended at the time of the incident. A nearby worker saw an electrical arc come from the bus duct to an adjoining piece of unistrut. Electricians applied a lockout/tagout to the circuits within the bus duct and verified that safe conditions existed, and the facility manager suspended all fork truck operations in the area. Although there was no damage to the fork truck and no injuries to the driver, the failure to recognize the overhead hazard resulted in superficial damage to the bus duct and an electrical near-miss. (ORPS Report RFO--KHLL-NONPUOPS2-1998-0009)

Investigators determined that although the ceiling was approximately 22 feet high, the bus duct was positioned at 11 feet 6 inches from the floor. A 220-V duct also ran next to the 480-V bus duct. Investigators determined that the fork truck driver had driven down an aisle under the bus duct to pick up his load. Because the load was wide, the driver had to raise it in order to clear some crates on each side of the aisle while egressing. With the load raised and the mast extended, the driver continued until he contacted the bus duct.

When operating fork trucks inside warehouses or buildings, operators should slow down and exercise caution at all cross aisles and other locations where vision is obstructed. They should never back up without looking behind first. As Figure 4-1 shows, they should always know the height of their fork truck and check the clearances, because not all overhead obstructions are marked or posted.

Managers held a fact-finding meeting and discussed the incident. They learned that the driver was an experienced equipment operator who knew the facility layout and had up-to-date training. Meeting members identified corrective actions, which included (1) conducting walk-downs of the routes of travel beforehand to identify any hazards and (2) using spotters when egressing aisles with extended masts.
